AVIATION INVESTIGATION REPORT

A01A0100

LOSS OF CONTROL - COLLISION WITH TERRAIN

BELL HELICOPTER TEXTRON 206B C-GLRA

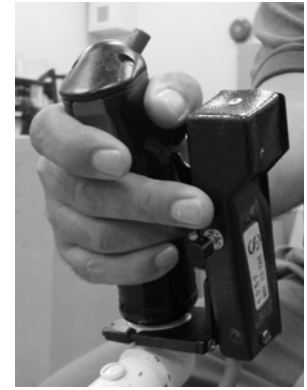
The helicopter was equipped with an agriculture navigation (Ag Nav) system. A remote switch for the Ag Nav system was mounted on a bracket attached to the left side of the cyclic stick grip. The helicopter was also equipped with a Simplex 4900 spray system; the control box for this system was mounted on the left side of the Ag Nav remote switch. The spray system control box incorporates an emergency dump switch, located on the forward side of the control box, which dumps the spray load when the dump switch is pressed in. This button is positioned to be depressed by the middle finger.

The Simplex control box and the remote switch for the Ag Nav system were removed from the accident helicopter and installed on another cyclic stick in the same positions as on the accident helicopter. It was found during simulations that only persons with large hands could operate the dump switch—although this was with the ring finger, not the middle finger—and still maintain a normal grip on the cyclic. An investigator with medium sized hands (the same size as the accident pilot's hands) had difficulty pressing the dump switch. The Ag Nav remote switch was then removed from the cyclic stick which allowed the spray system control box to be mounted on the cyclic stick grip. Simulations in this configuration showed that even those with small hands could easily access the dump switch while maintaining a normal grip on the cyclic.

The position of the Ag Nav remote switch, between the cyclic stick grip and the spray control box, made it difficult for the pilot to activate the dump switch because it was out of reach while his hand was on the cyclic. While he was attempting to dump the spray load, the pilot's middle finger was likely just catching the edge of the dump switch and sliding off the switch rather than fully depressing it.

1. The helicopter took off downwind, conducive to unanticipated right yaw; the helicopter yawed to the extent that control was lost and could not be recovered before it struck a tree.
2. The Ag Nav remote switch, positioned between the cyclic stick grip and the spray control box, likely prevented the pilot from easily reaching the dump switch, adversely affecting a quick recovery of the helicopter.
